Test report

Salt fog testing of tubing clamps

ASTM B-117 or ISO 9227

TEST OBJECT
Tubing clamps with tubing

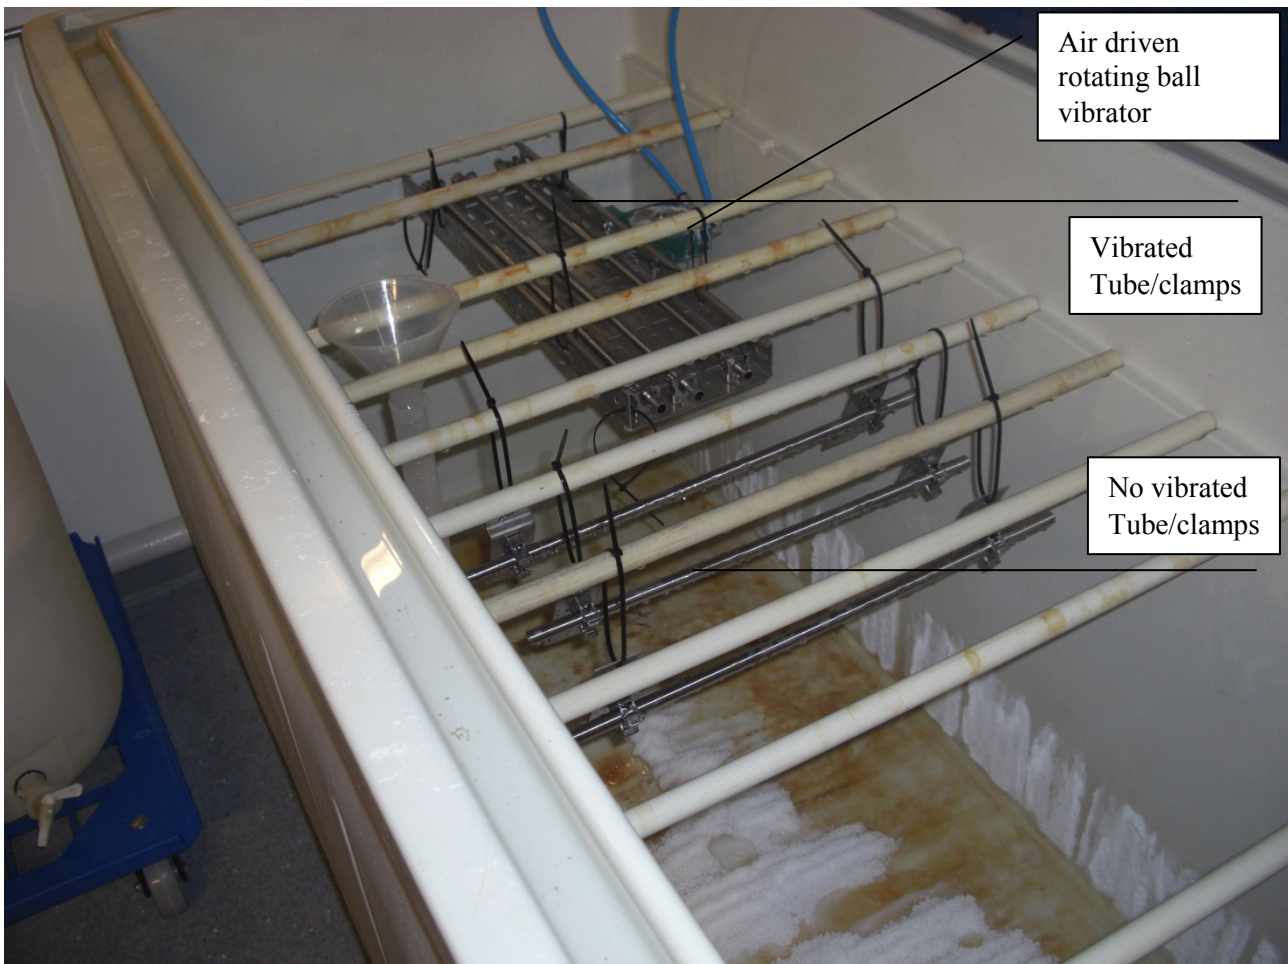
Figure 1 Picture of the test specimens inside the salt spray chamber.

The test was made in a salt fog chamber according to ASTM B-117 / ISO 9227. The testing time was 312 hours (13 days). This corresponds to about 5 years of vibration on a platform. During one year a platform experiences around 7 mill vibrations. The 254SMO clamps and pipe and AISI316L clamps and pipe were attached to a BVS Cable Tray of AISI 316 and exposed to vibrations during the whole testing period. The setup is shown in Figure 1. The vibration was excited by a ball vibrator that had a frequency of about 30 Hz.

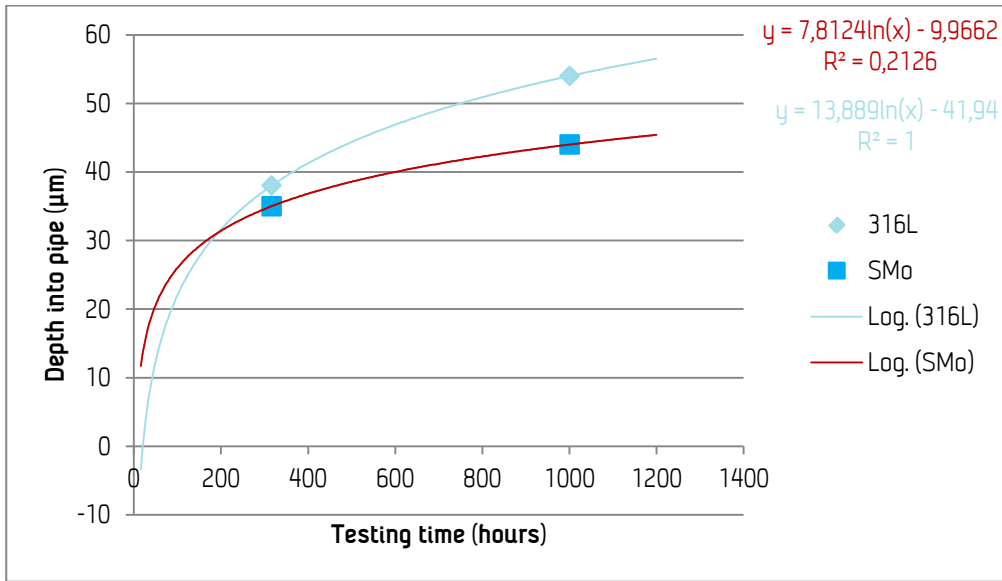
Figure 2 Penetration of pipe as a function of time. (Normal wall thickness of the tubes used is ca 800 µm)

It can be noticed that the depth of the marks is not very different on the pipe tested for 312 hours and 1000 hours. This means that after an initial deformation/corrosion the depth increase rate is significantly reduced. This is visualized in Figure 1 where logarithmic curves are fitted to the result. The fitted curves **indicate** that the deformation/corrosion will never penetrate the pipe i.e. never reach the wall thickness (WT=800 µm) of the pipe.
